CPUC Covered Conductor Workshop

February 27, 2019

SCE Covered Conductor Design

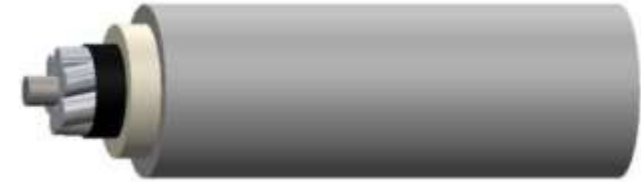
Two Layer

- Thicker overall insulation
- Improvement on insulation
- Tougher outer layer for abrasion protection
- Improvement on UV

Three Layer
(Current Standard)

- Capable of withstand long-term contact (semi-conductive shield)
- Higher conductor rating (cross-linking)
- Abrasion improvement
- Improved UV and tracking resistant (Titanium dioxide)

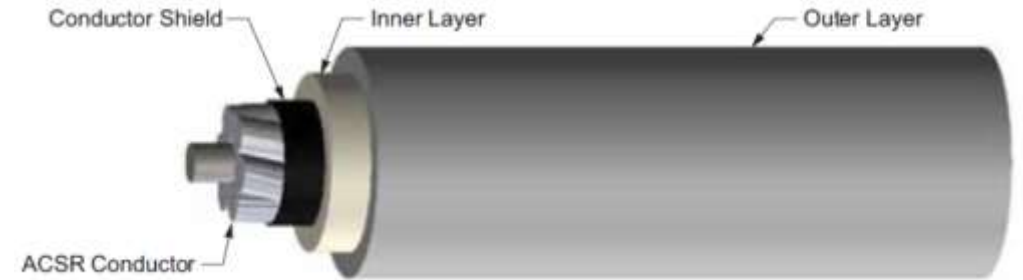
- Semiconducting Thermoset Polymer
 - Reduces stress, transforms strands into a single uniform cylinder
 - Extend service life of the covered conductor in case of contacts

Flux lines without a conductor shield

Flux lines with a conductor shield

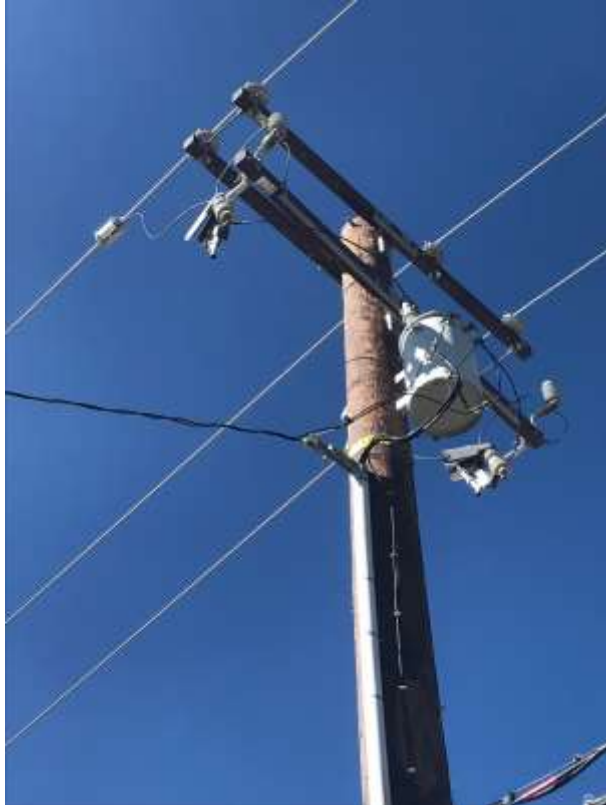
Cross-arm Construction
(aka Tree Wire)

Most of SCE installations on Cross-arm
(SCE uses grey to reduce the impact of sun
light heating effect, thus increase ampacity)

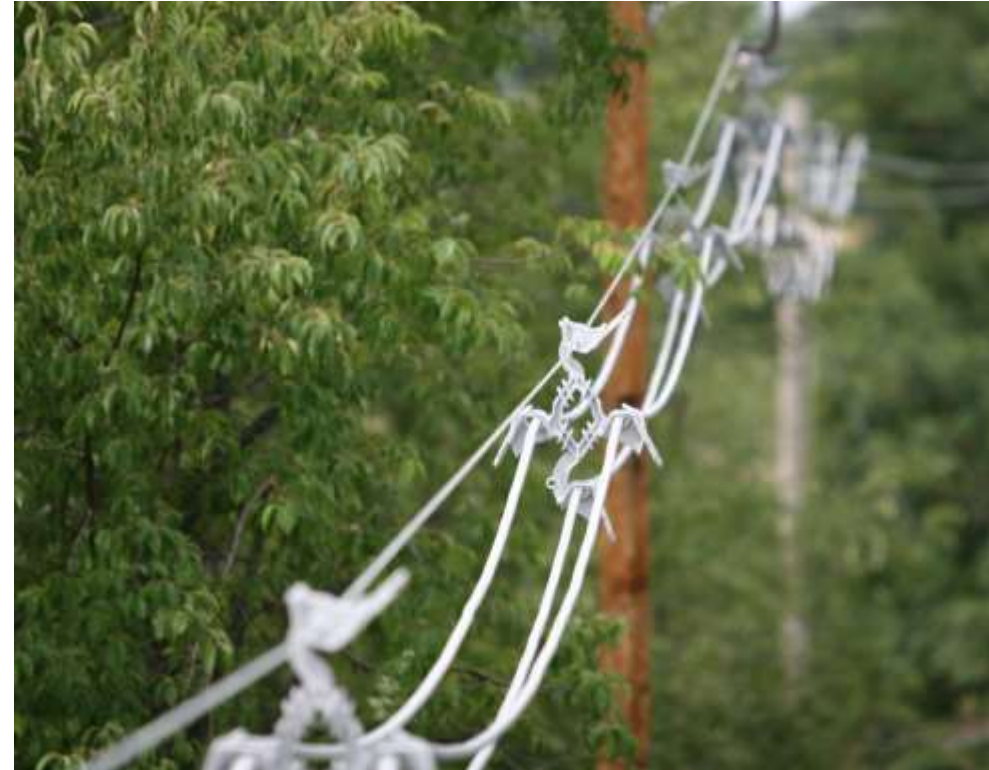
Compact Construction
(aka Spacer Cable)

Some installations will be spacer cable
(e.g. replacement of tree attachments)

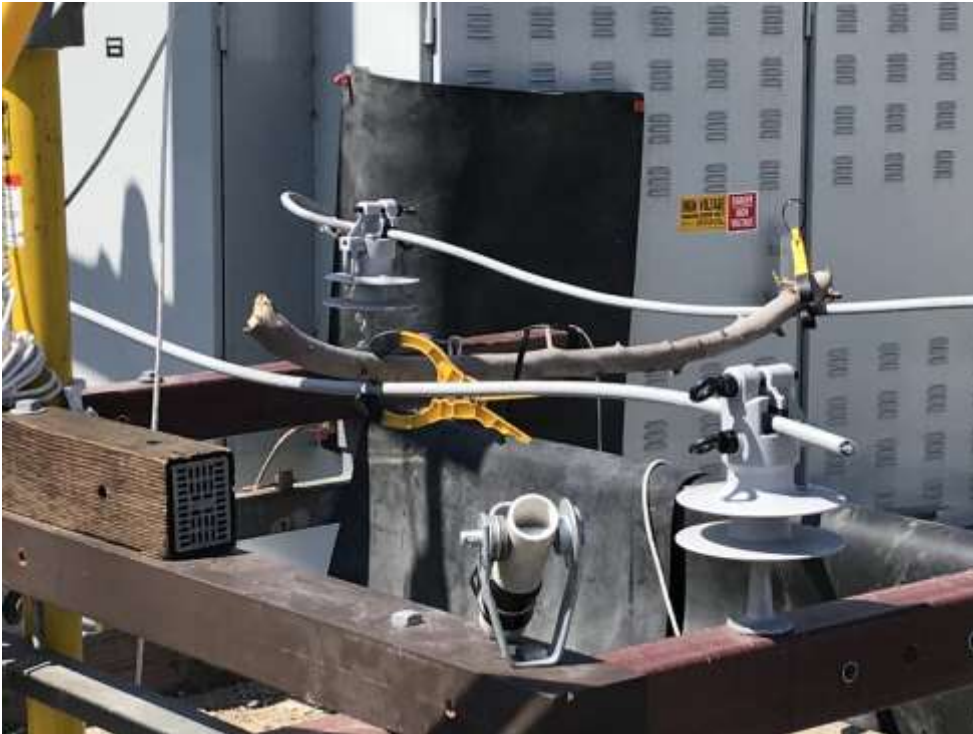
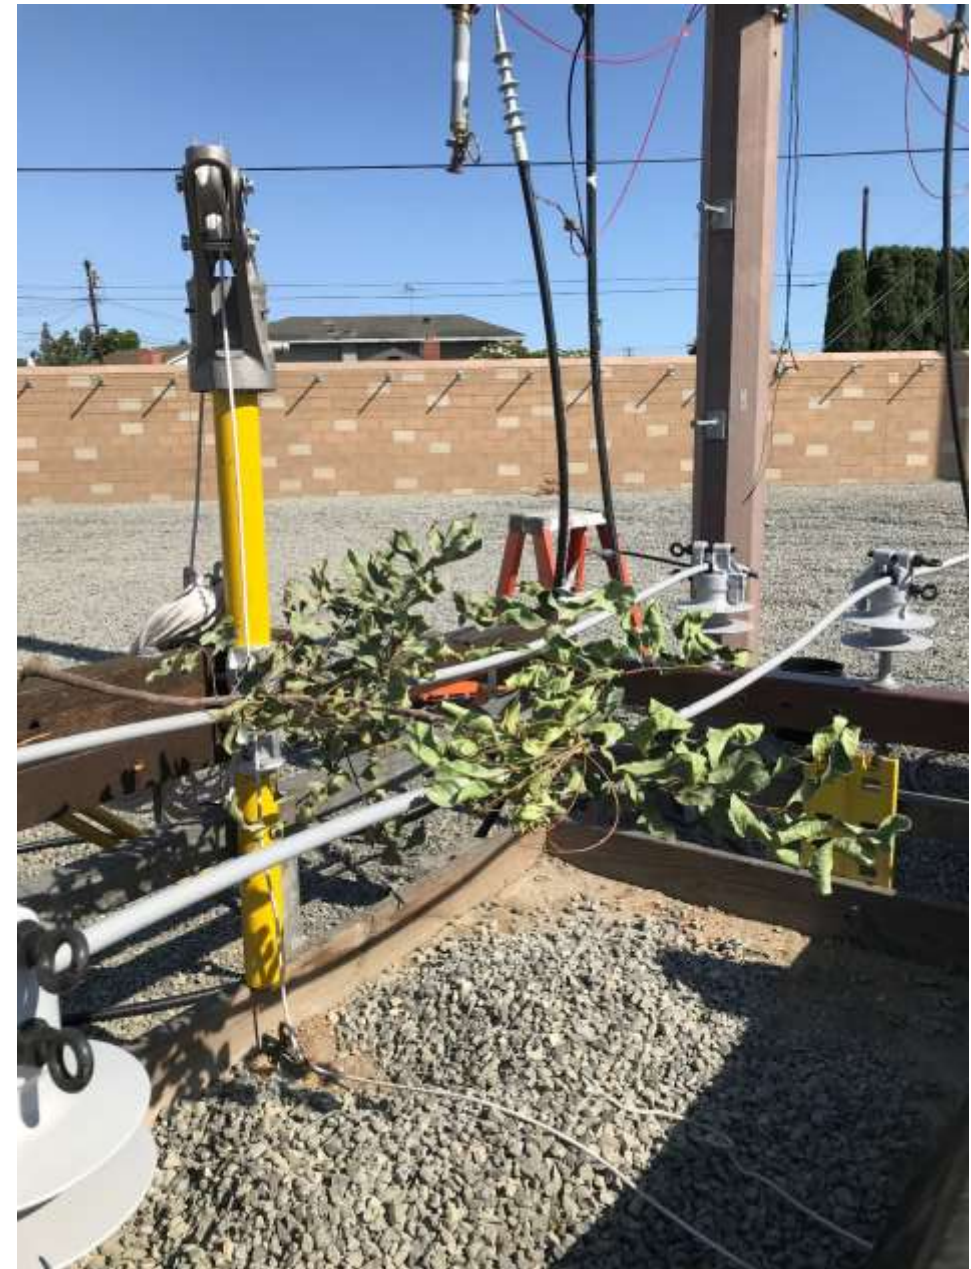
Tree Branch contact

- Energized at 12 kV
- Observations
 - No arcing
 - No damage to the covered conductor
 - No damage to the tree branch

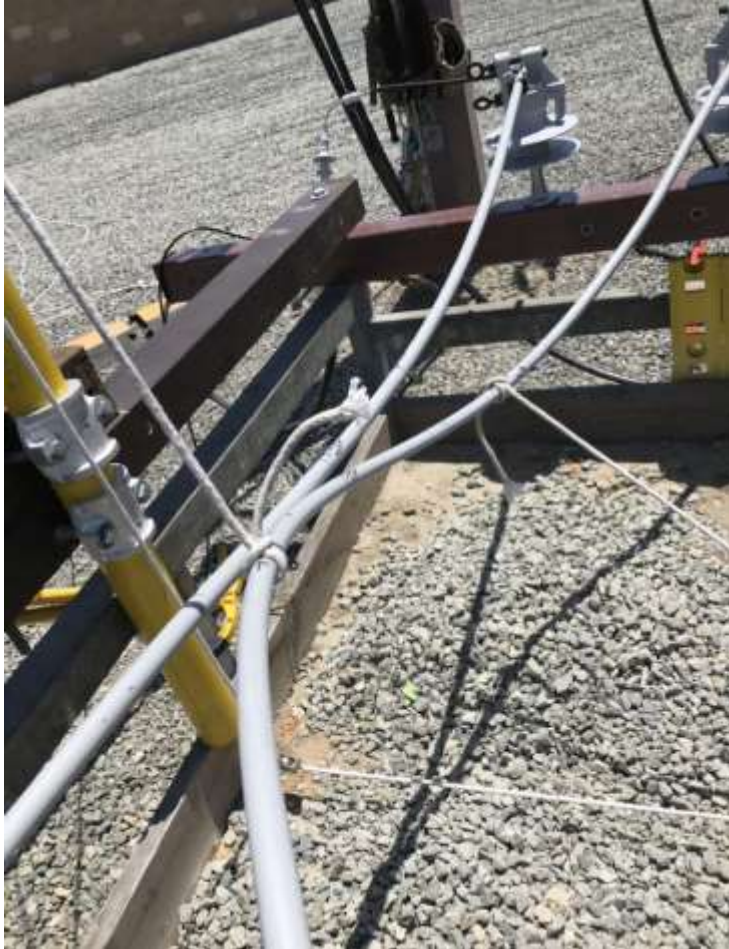
Conductor Slapping

Testing Other Contacts: No Arcing and Damage to Covered Conductors

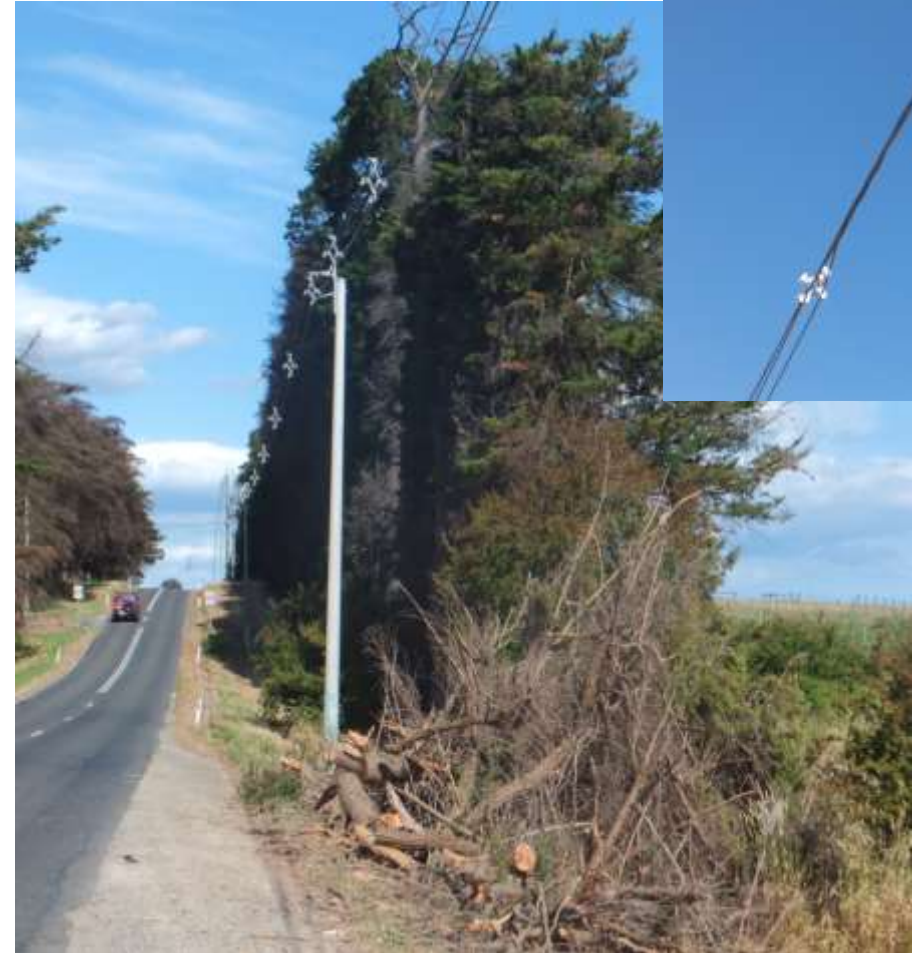
Ausnet – Covered Conductor Ignition Mitigation

- A cypress tree blew onto covered conductor during a storm in December 2015
- Ausnet personnel responded three days after the storm and found the tree on conductors
- No broken conductor, no service interruption, no ignition.
- The spacers were knocked off and the conductors wrapped up.
- Insulation thickness design on each covered conductor prevented a phase-to-phase fault.
- power shutdown to unwrap the conductors and reinstall the spacers.

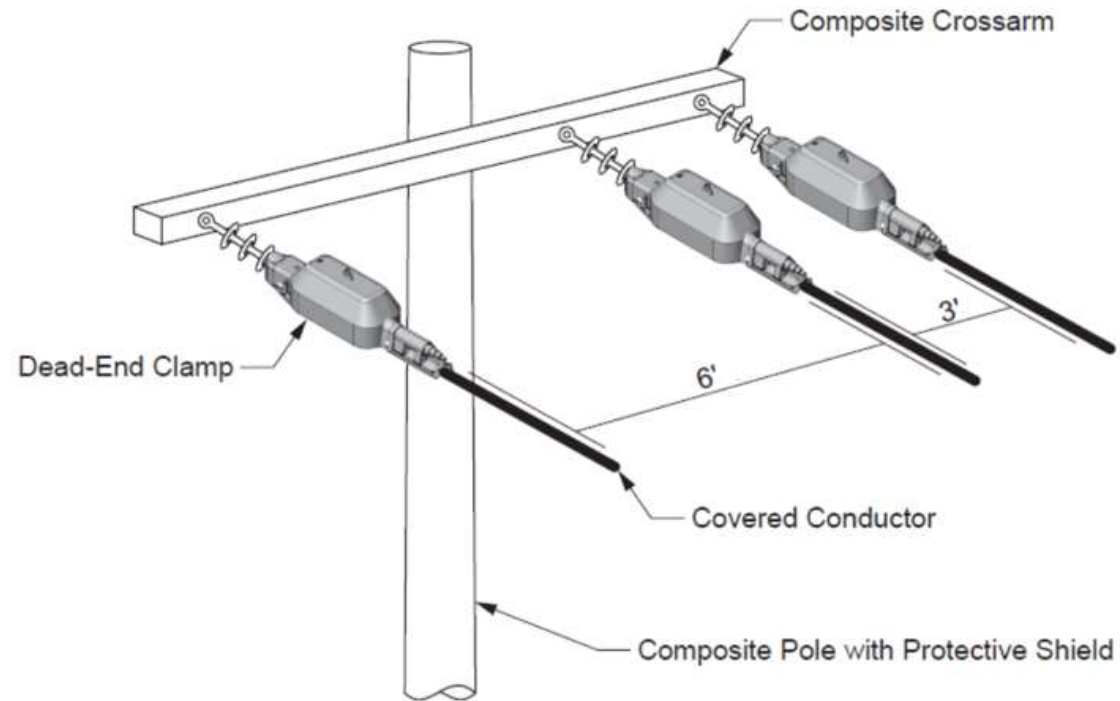
Three-wire Dead-end Construction

- Covered Conductors need to be stripped at the dead-end
- Use Dead-end Covers to protect exposed areas

Same concept for four-wire and two-wire constructions

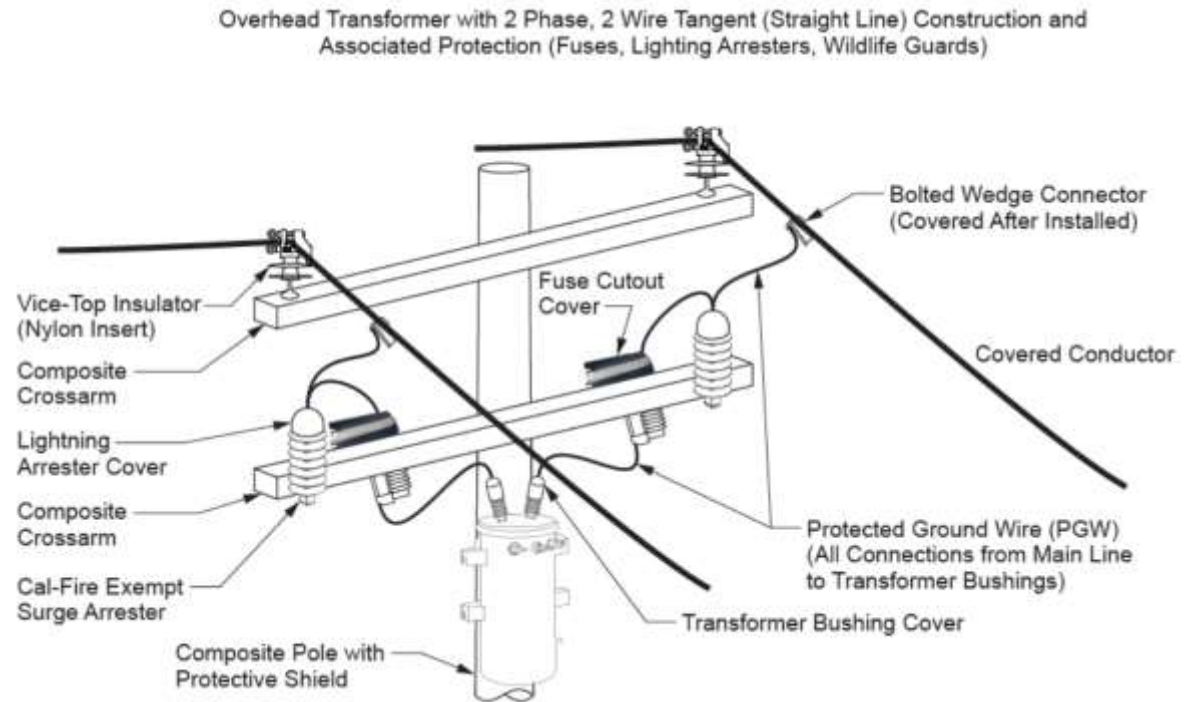
Tangent 2 Wire with Transformer Construction

- **Use Surge Arresters at all Overhead Equipment**
 - Treat Covered Conductor systems like high lightning area
 - Covering prevents the arc from moving
- **Use Bolted Wedge Connector**
 - Cover after installation
- **Use Protected Ground Wire**
 - Connections to equipment will be covered
- **Wildlife protection on equipment**
 - Cover Lightning Arrester, Transformer Bushing, and Fuse

Same concept for connecting to other equipment: capacitor, switch, remote automatic recloser, etc.

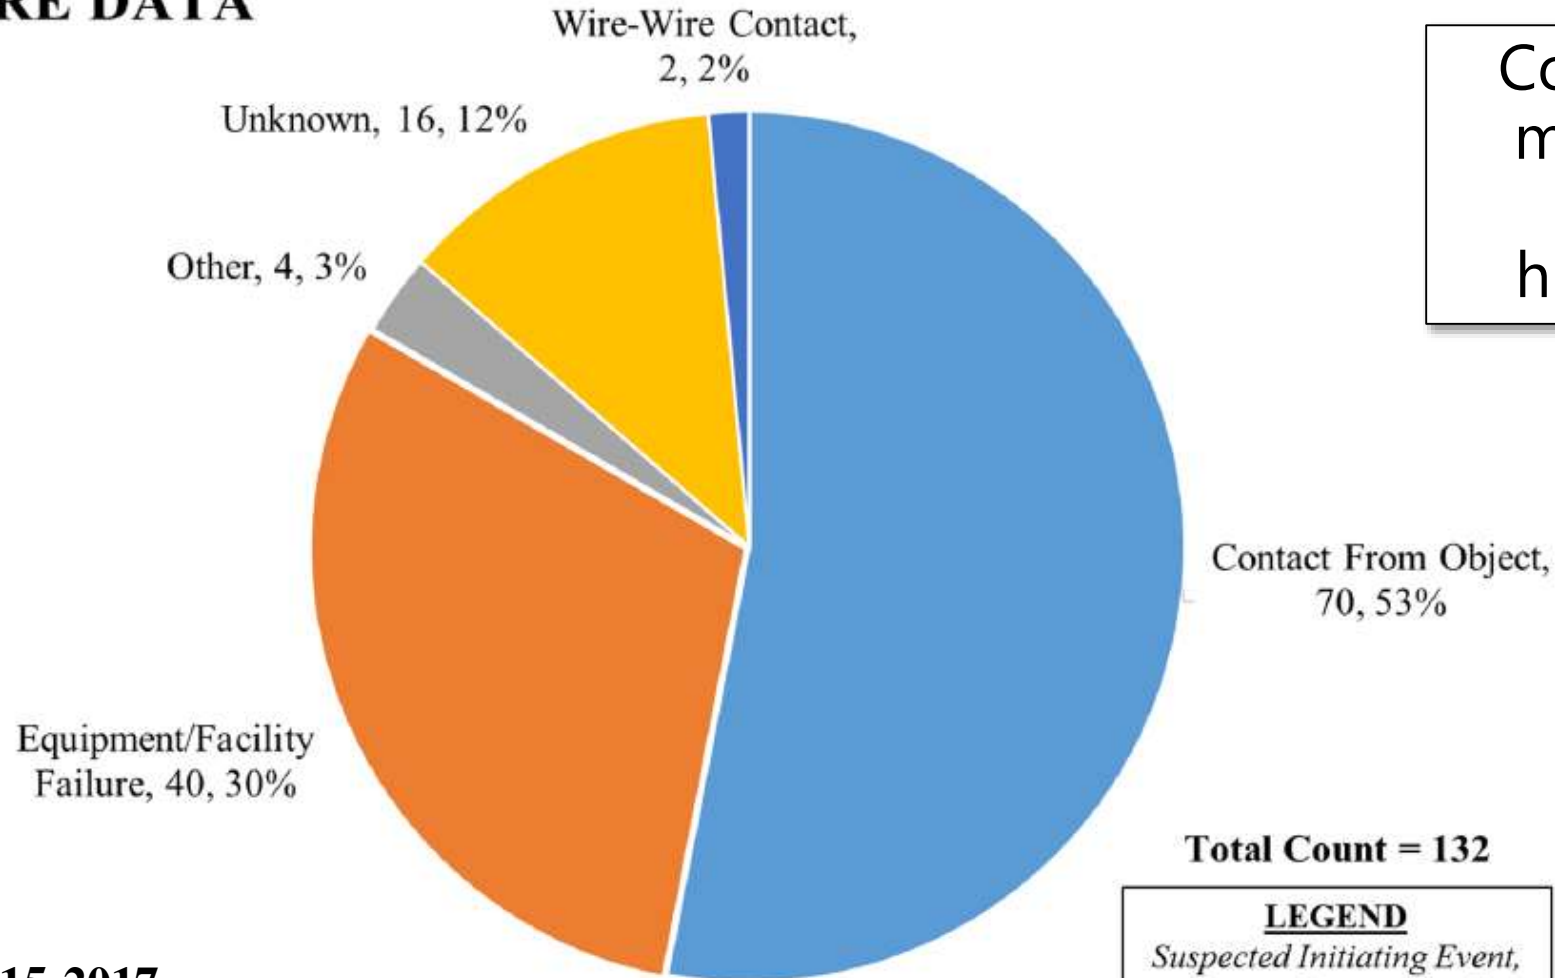
SCE Historical Fire Causes

Covered Conductor mitigates ~60% of drivers causing historical ignitions

Total Count = 132
